A GUIDE
TO
EROSION REDUCTION
ON
NATIONAL FOREST
TIMBER SALE AREAS

U.S. FOREST SERVICE
CALIFORNIA REGION
1954

R. P. McRorey California Region
N. F. Meadowcroft California Region
C. J. Kraebel California Forest and
 Range Experiment Station

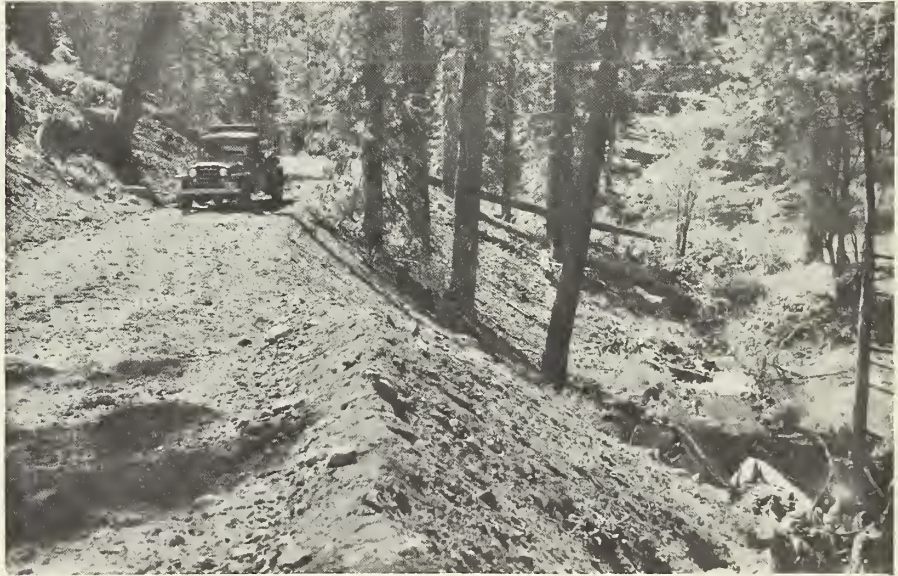
40.

Temporary road properly located along a creek.

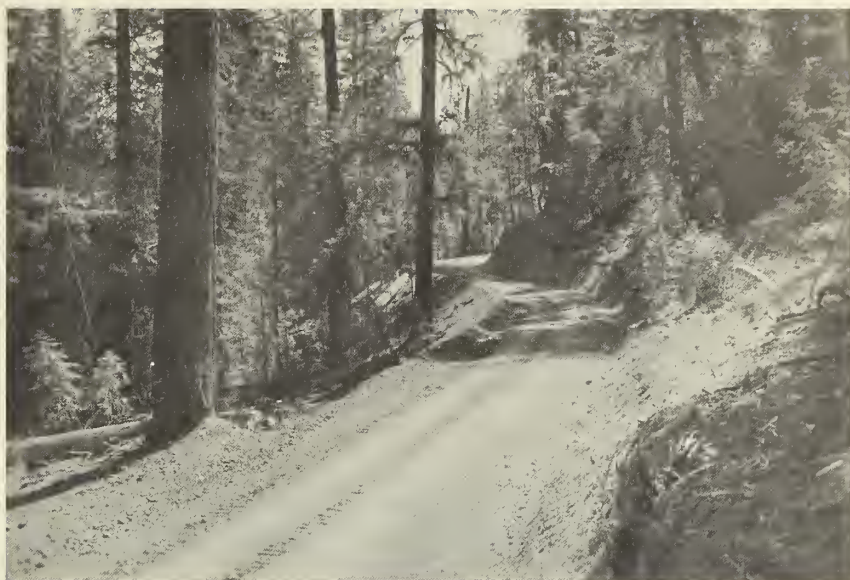
41.

Excellent stretch of secondary road on hillside location in sandy soil.

Picture 41 illustrates a secondary road built on a location which evidences consideration for the erosion values of the soil type - in this case a sandy soil. The grades were held to 6% and below, and ample drainage was provided. No erosion in evidence. Incidentally, other good features are illustrated by this picture: Machine shaped back slopes, ample inside ditch, raised shoulder (proper for this soil type), and clean roadside.

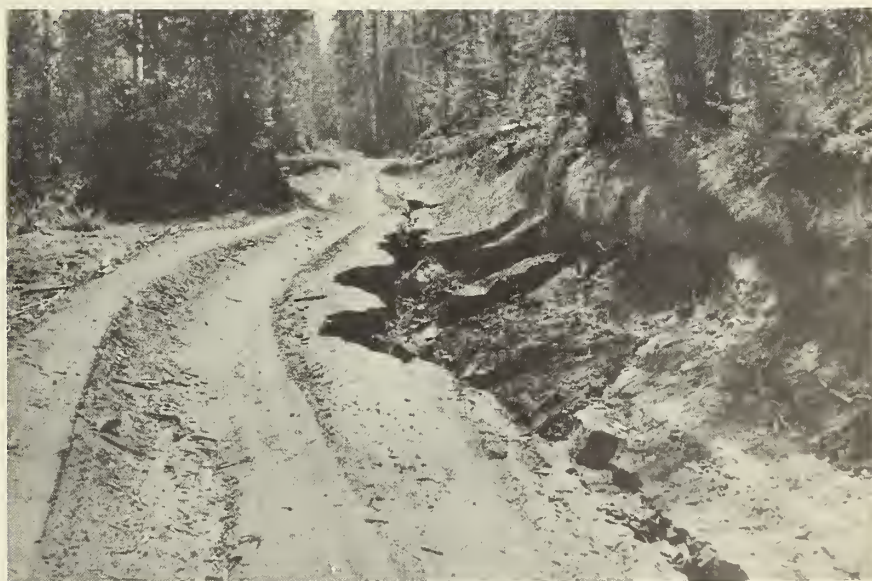
42.

Temporary road in very light d. g. soil showing deep ditch erosion.

Picture 42 illustrates use of excessive grade (10% \pm) for the soil type, a very light decomposed granite soil. Grades in this type soil should be held to 6% or below if possible. If absolutely necessary to use steeper grades, the erosion can be minimized by providing frequent and adequate cross drains (culverts or dips) to remove ditch water, paving ditches with hand laid rock riprap, and mulching fill slopes with forest litter. This picture illustrates another bad feature - undercut back slope - which results in bank sloughing, ditch plugging, and accelerated erosion of the road.

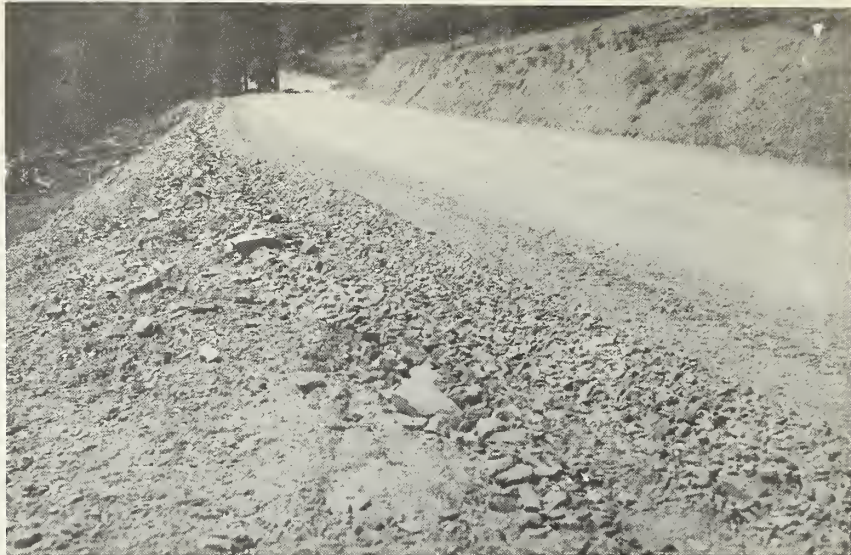
43.

Main road on hillside location in rocky shale soil.

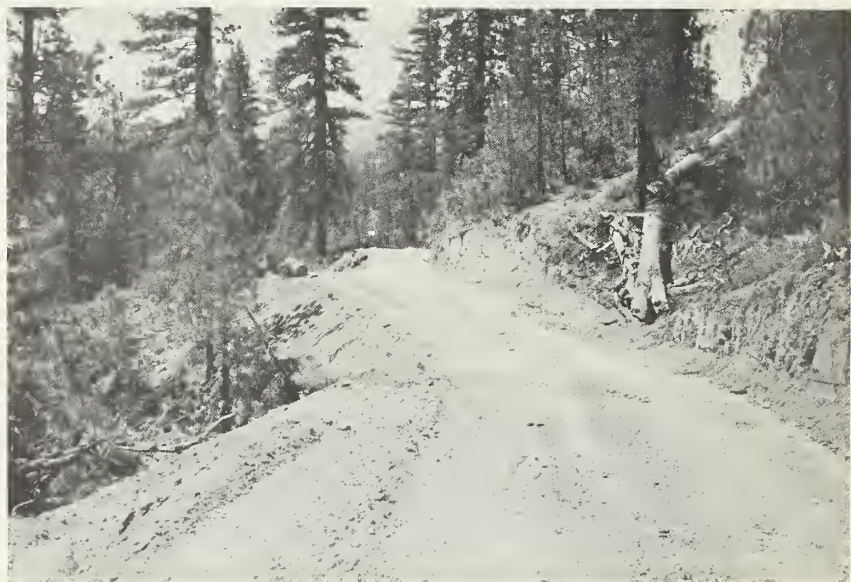
44.

Well constructed temporary road through rolling country.

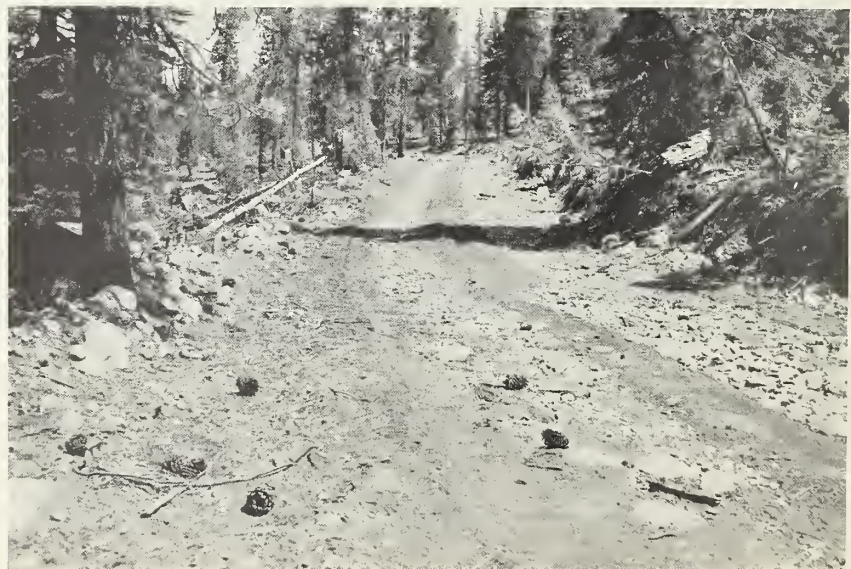
45.

Abandoned temporary road showing severe erosion of the roadbed.

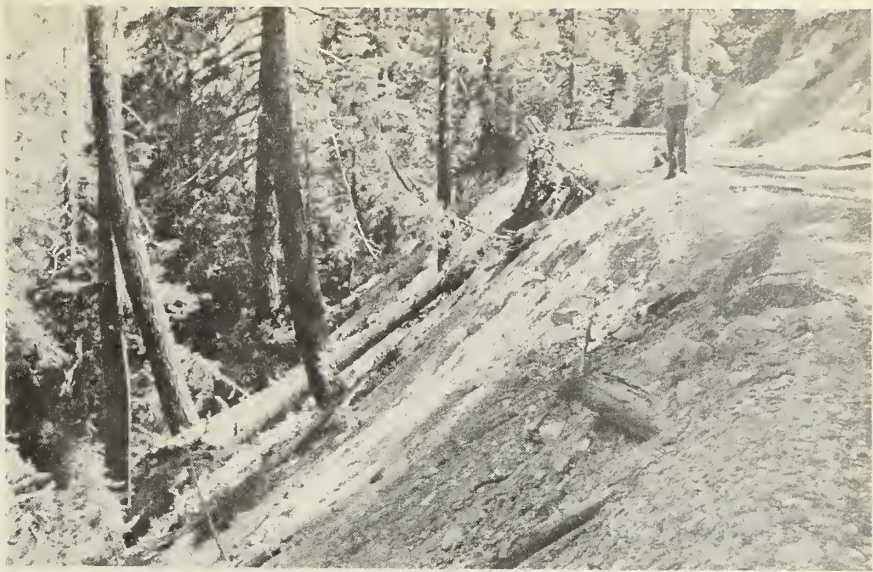
46.

Temporary road in steep country and shale soil,
showing location along live stream.

Picture 46 illustrates a temporary road location along a live stream. The roadbed is about 25' above streambed - in this case a sufficient distance for excavation overcast to catch above high water level. A screen of trees and reproduction has been left between the road and the stream. This location retains a good appearance of the scenery. It also avoids pollution of the stream by silt and debris and maintains shade on the stream, both of which are vital to fish life.

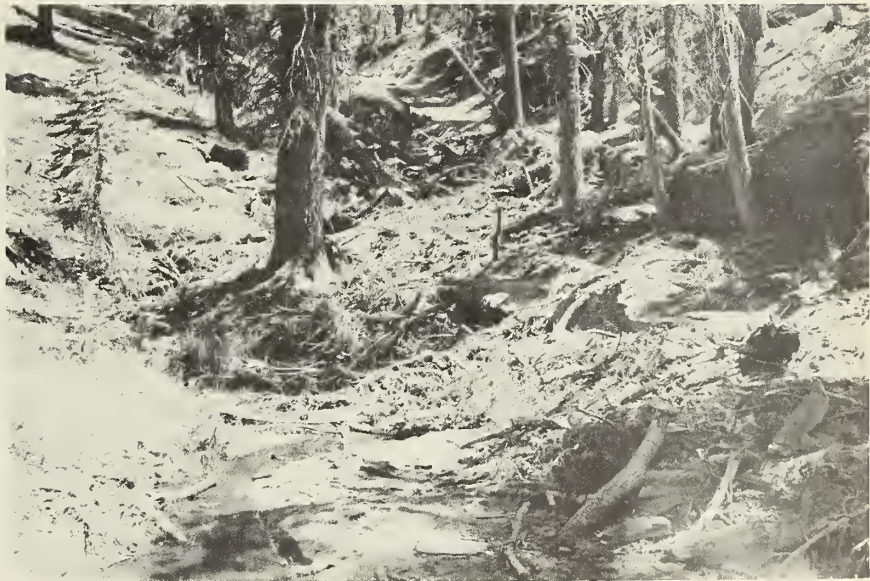
47.

A small creek polluted with silt and debris from a road
constructed too close to the channel.

Picture 47 shows the results of a location too close to the stream channel. In the background the road is almost in the streambed. There is no apparent reason why this location had to be so close to the stream. The cross slopes are light and no rock is in evidence. A location above and away from the streambed, such as shown in the preceding picture would avoid this unsightly condition and maintain stream conditions largely undisturbed. The situation here could have been alleviated to some extent by clearing and slash disposal in advance of excavation.

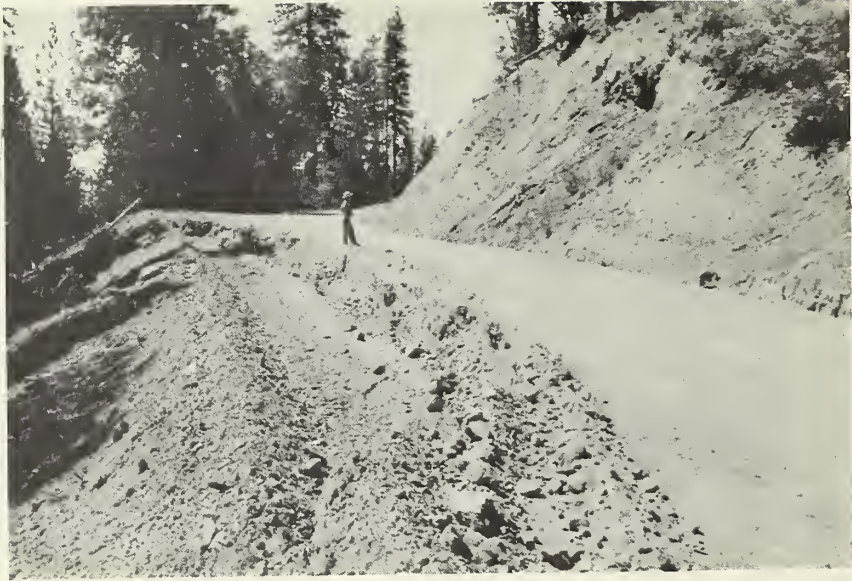
48.

Main road in difficult location across wet slide area in serpentine-shale formation.

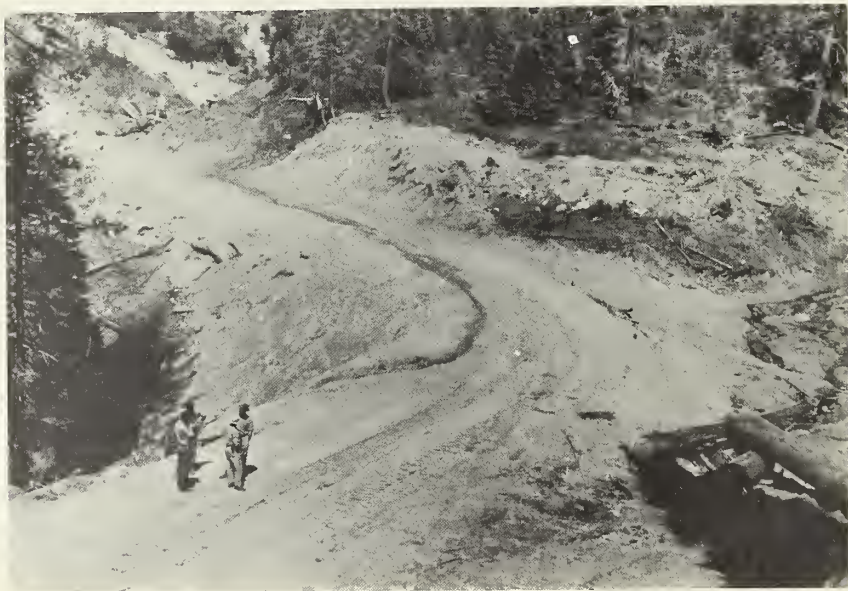
49.

Main road constructed in a wet location at the crossing of three ravines.

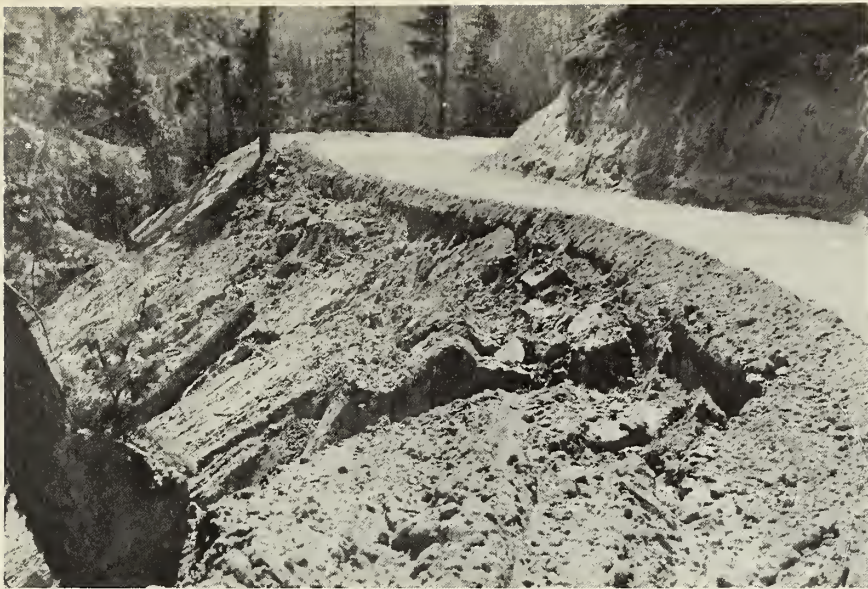
50.

Main road in difficult location, through decomposed granite in very steep terrain (over 80 per cent), resulting in sloughing and settlement of overcast fill.

Pictures 50 and 51 illustrate some of these problems. Excavation of roadbed on slopes above 65% results in long "sliver" fills which are very difficult to compact satisfactorily. This results in shoulder settlement, loss of shoulder berm, and serious fill slope erosion. The long cut slopes also increase the area exposed to erosion. Road construction on such locations frequently calls for special features such as retaining walls, intercepting ditches above cut banks, extra large raised shoulder berms, more frequent drainage structures, fill compaction and fill stabilization. Berm outlets require long down spouts or paved outlets. Special care is necessary in providing for drainage to insure that a minimum of water reaches the exposed surfaces. Heavy mulching of fill slopes with forest litter is also usually necessary to prevent erosion damage. All of these features add to the cost of the road and emphasize the desirability of avoiding such locations when possible.

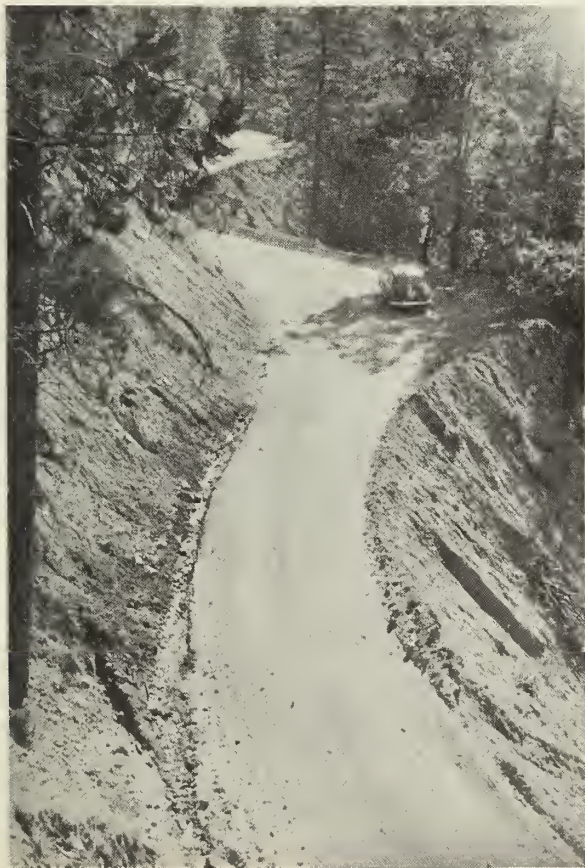
51.

Main road in a problem location on a very steep mountain side (80-90 per cent) in light decomposed granite soil.

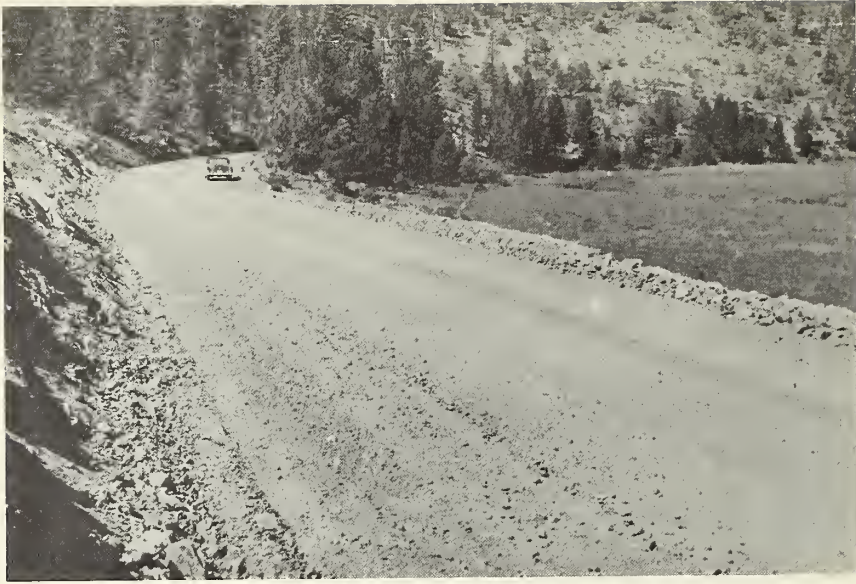
Main road well located and constructed. Location around edge of meadow avoids damage to this important grazing resource.

Pictures 52, 53 and 54 illustrate good and bad road locations, and an example of meadow damage that resulted from improper road location and construction. It is usually possible to skirt a meadow by locating the road at the toe of the adjacent slope, as shown in picture 52. When a crossing through a meadow is necessary, it should be located at a narrow point in the meadow, and should be built as a low through-fill with borrow material from outside the meadow. Ample culverts should be provided for drainage through the fill.

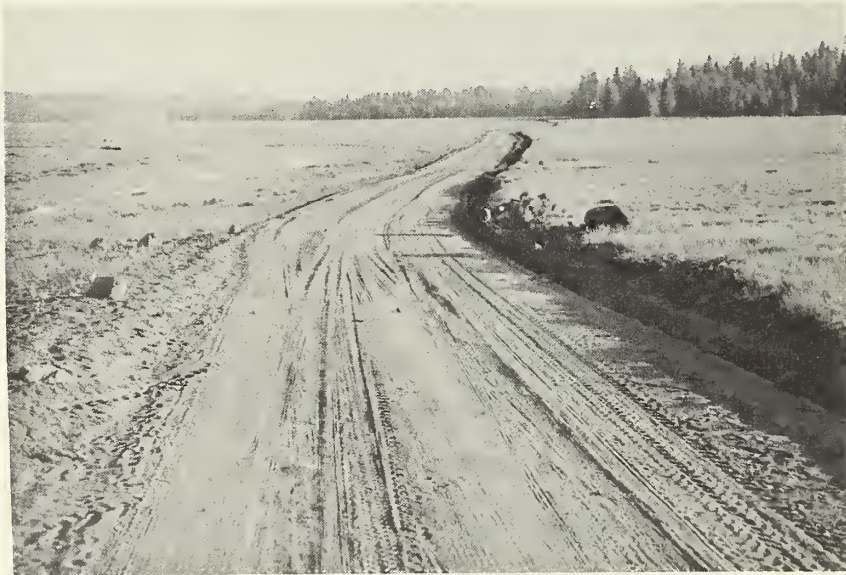
53.

Secondary road, showing poor location and construction features; crossing through center of meadow instead of skirting its edge, and cutting through meadow sod to place the roadbed on mineral soil below the sod level. This is a certain way to start a gully across the meadow, by diversion of natural channels.

Meadow crossings by roads and skid trails have been responsible for gullyng, draining and drying up meadows that were previously well watered and green. Tractor and skid trails should not ordinarily be permitted to cross meadows. It is usually possible to skirt meadows, but where this is not possible they should be crossed at a narrow point on fill material which has been hauled in. (Photos 52, 53, 54).

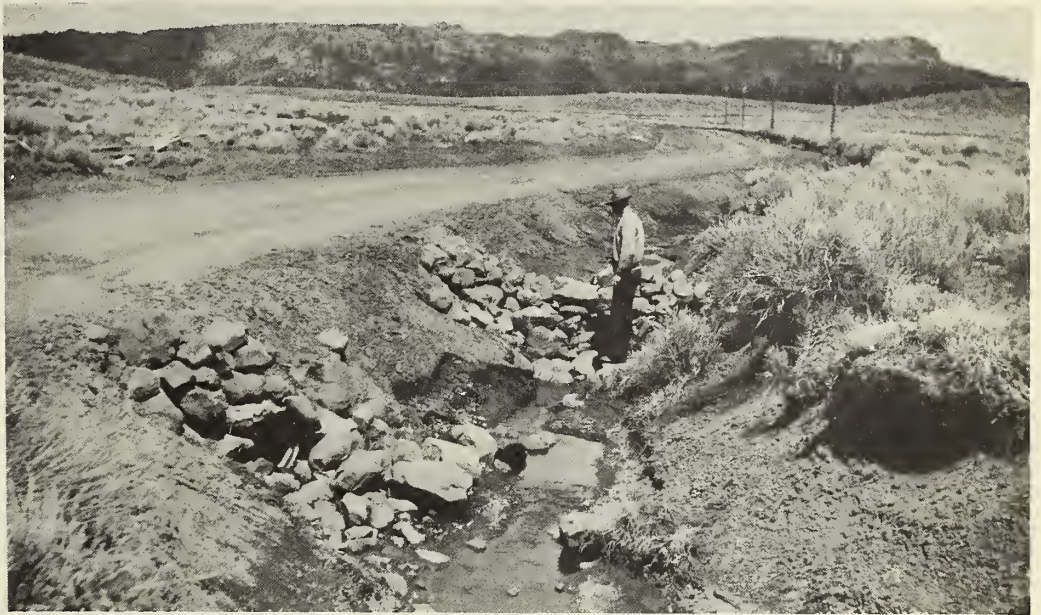
54.

Example of meadow damaged by road construction. The roadside ditch, originally formed by excavation of material for the road, has eroded deeply and drained the meadow, thus favoring the spread of sagebrush at the expense of grass. Several check-dams have helped to stabilize the gully, but have not remedied the damage.

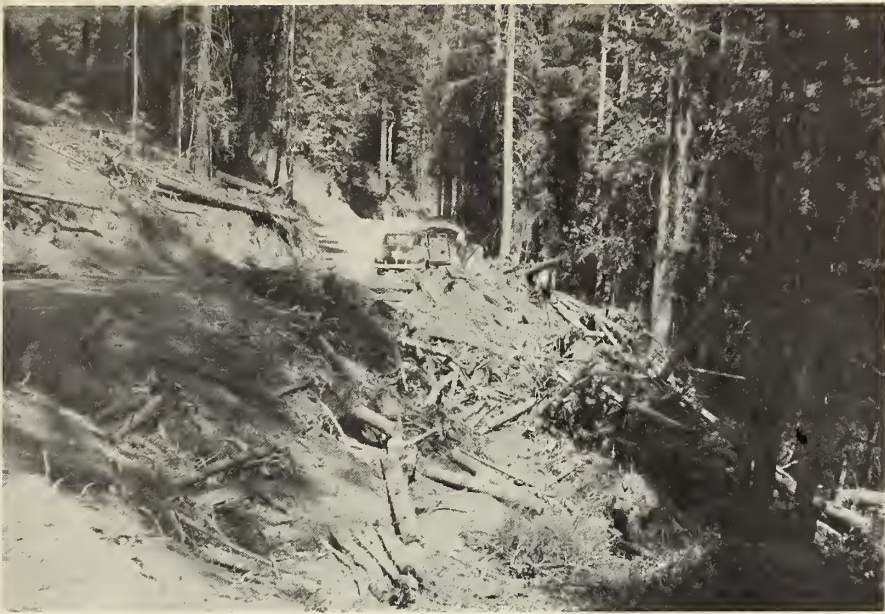
55.

Main road through area with heavy cover constructed without advance clearing of construction zone. Much slash and logs are covered by excavation overcast and incorporated in the roadbed. As this material rots, the road shoulder settles, disrupting the drainage system, and resulting in serious erosion.

Pictures 55 and 56 illustrate this point better than words.

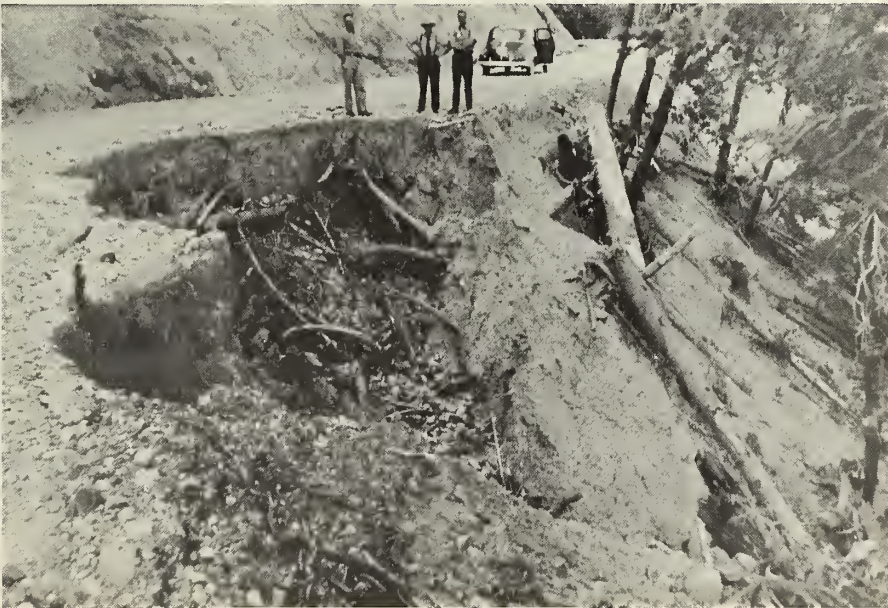
56.

Main road constructed with slash in fill has resulted in serious roadbed failure. This is the result of failure to clear the construction zone in advance. The damage is three-fold: road out of service, high cost of repair, and downstream siltation. All could have been prevented.

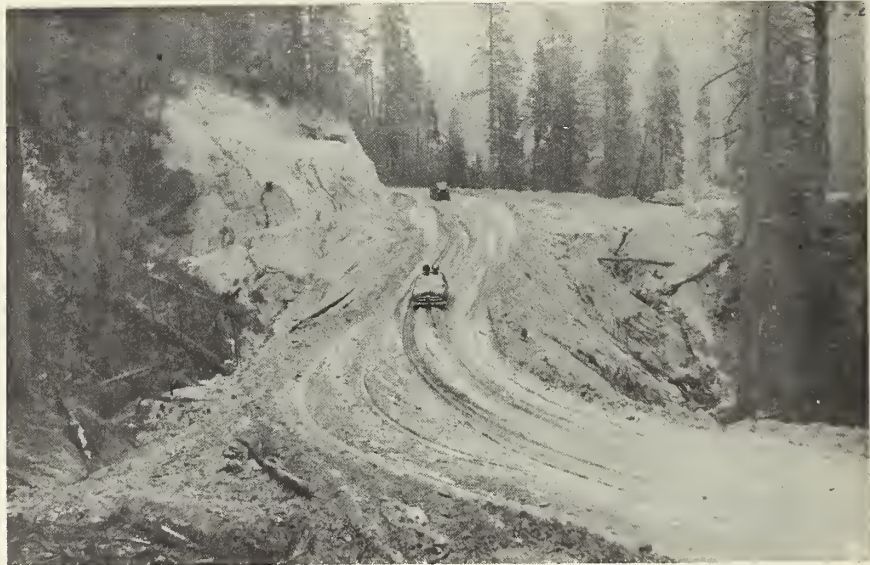
57.

Picture 57 illustrates a case in which poor road location resulted in badly unbalanced cuts and fills, and poor construction practice aggravated the situation by disposing of excess material downslope to constitute an erosion problem. Moderate adjustments to grade and center line during construction would have prevented much of this.

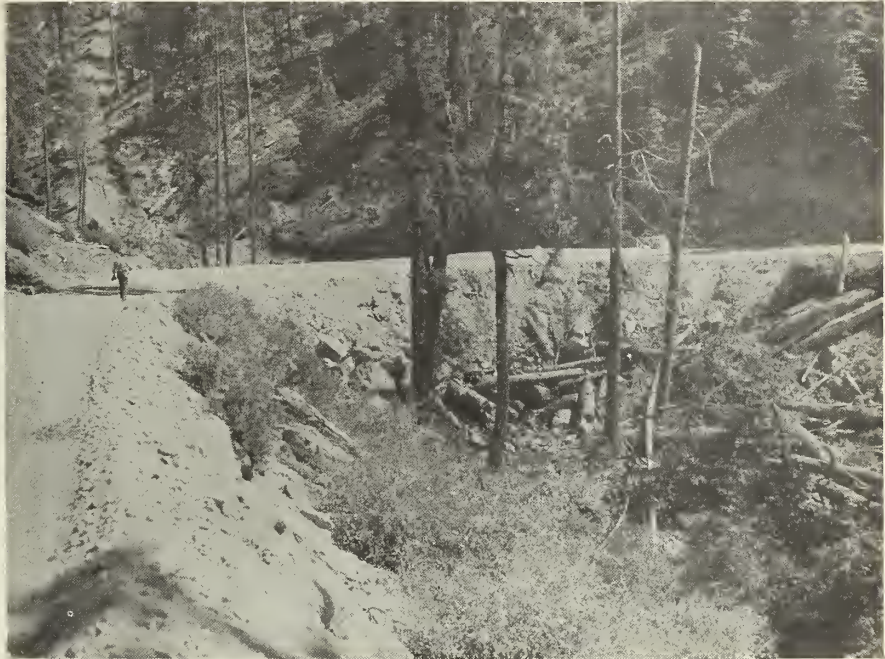
58.

Picture 58 illustrates an example of carefully balanced cuts and fills. There is no excess waste yardage spilled over into the stream channel. A careful location job followed by correct construction practice has resulted here in a well balanced stream crossing and no serious erosion problem. The logs and slash in the stream channel, however, should have been cleaned up.

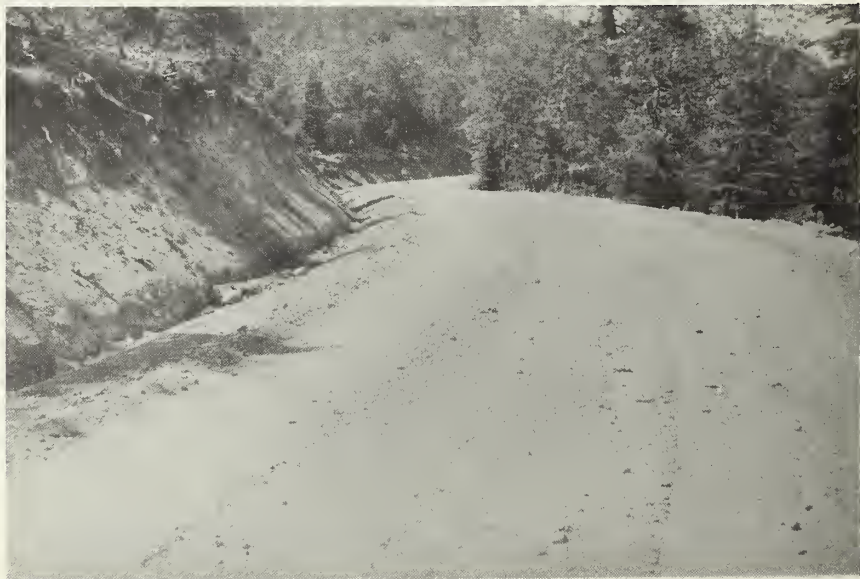
59.

Picture 59 shows a road which is otherwise well designed and constructed but, because the cross drainage culverts are too far apart (500 - 700 feet), the inside ditch is eroding. In this case culverts spaced at approximately 350 feet would have prevented the ditch erosion, and resulted in a thoroughly satisfactory road.

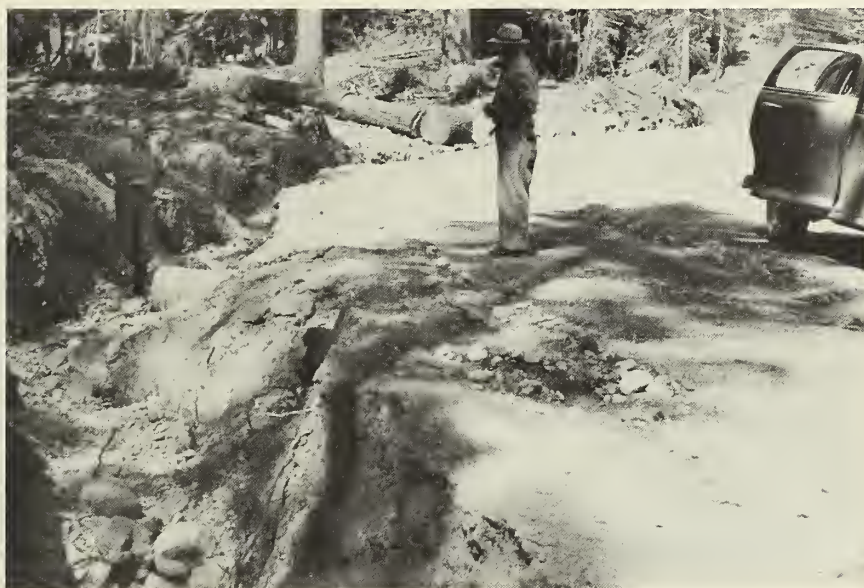
60.

Picture 60 illustrates a more aggravated example of insufficient cross drainage culverts. In this case the culvert spacing was 700-800 feet on an 8% grade. Culvert spacing should not have exceeded 250-300 feet in this case. The excessive spacing has resulted in volumes of water beyond the culvert capacities. Culverts were by-passed and serious ditch erosion developed. Remedial measures for this situation will now require installation of properly spaced and installed culverts and filling of the eroded ditch with gravel or other erosion resistant material. Cut-off walls or dykes of impervious material will have to be provided immediately below each culvert intake to prevent further by-passing.

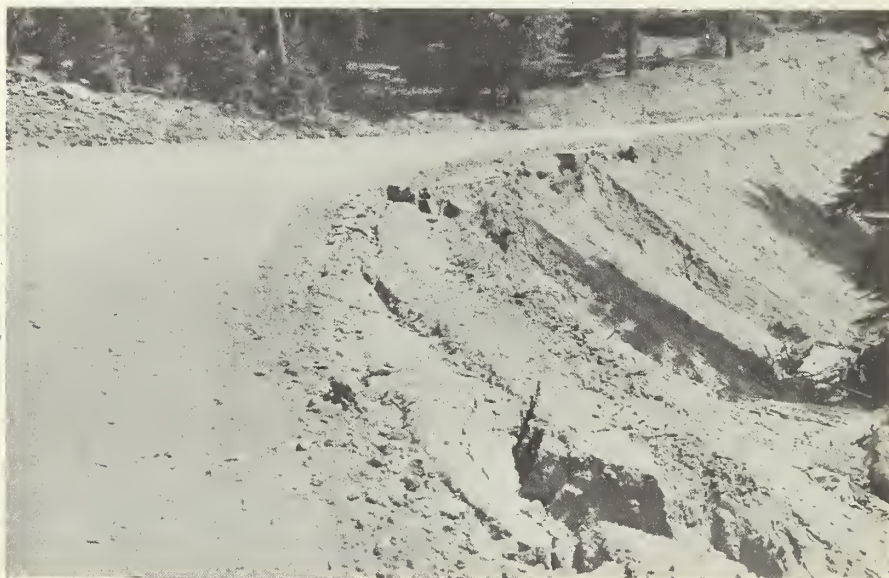
61.

Main road in highly erodible decomposed granite soil, showing severe erosion of the fill slope, the consequence of the lack of drainage control.

Picture 61 illustrates another type of road drainage fault frequently found on poorly located and constructed roads. The curve superelevation (not common on logging roads) results in an outsloped road surface. No raised shoulder berm and drainage outlets have been provided at the low inside edge of the curve. This has resulted in all roadbed water running down the erodible fill slope, with results shown in the picture. In this situation, with highly erodible decomposed granite soil, forest litter mulch and fill slope planting should have been installed in addition to raised shoulder berms and paved spillways. Forest litter mulch treatment is illustrated by Picture 62.

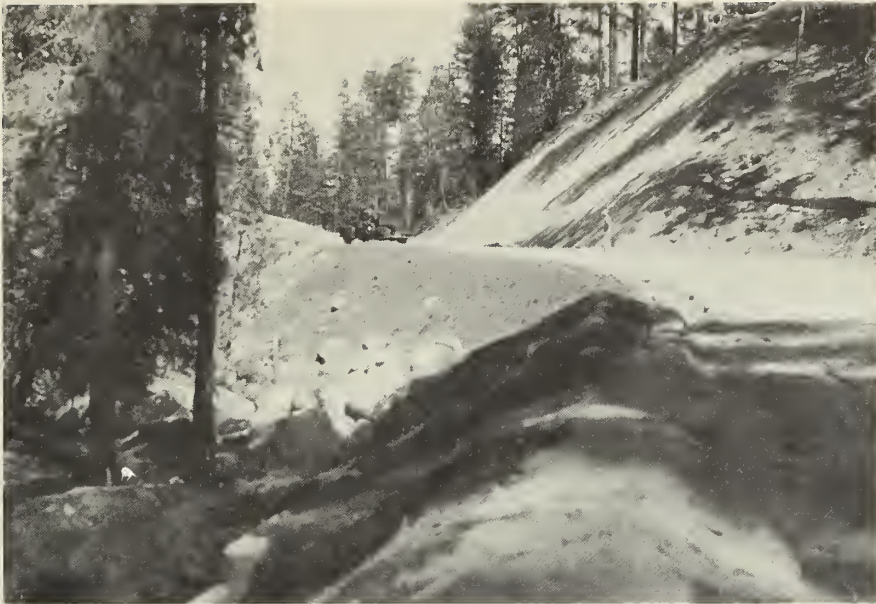
62.

A mulch of forest litter, in this case mostly pine needles, applied to a depth of 2 inches to this road fill slope has provided immediate protection against erosion. The seeds of trees and shrubs which such litter usually contains will provide permanent cover. This inexpensive treatment is suited to all classes of logging roads where erosion proofing is required.

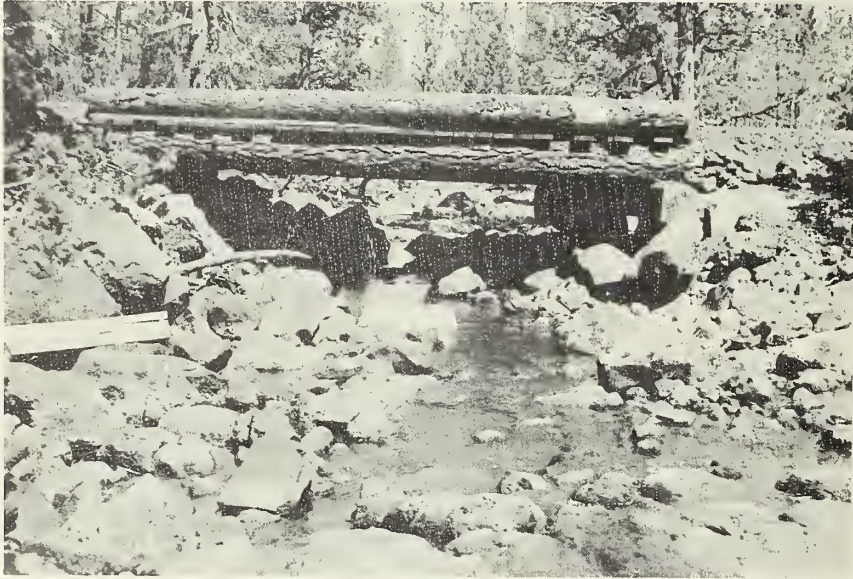
63.

Log bridge on temporary road will accommodate high flows without damage. Where use of road is known to be for a limited period this type of structure is preferable to earth-fill crossings which will wash out every winter.

Picture 63 shows a temporary log bridge on a temporary road.

Because green unpeeled logs were used, this bridge will have a short life. At the end of the period of log hauling this structure should be removed and the channel restored. Such structures should never be built on permanent roads except as an emergency measure.

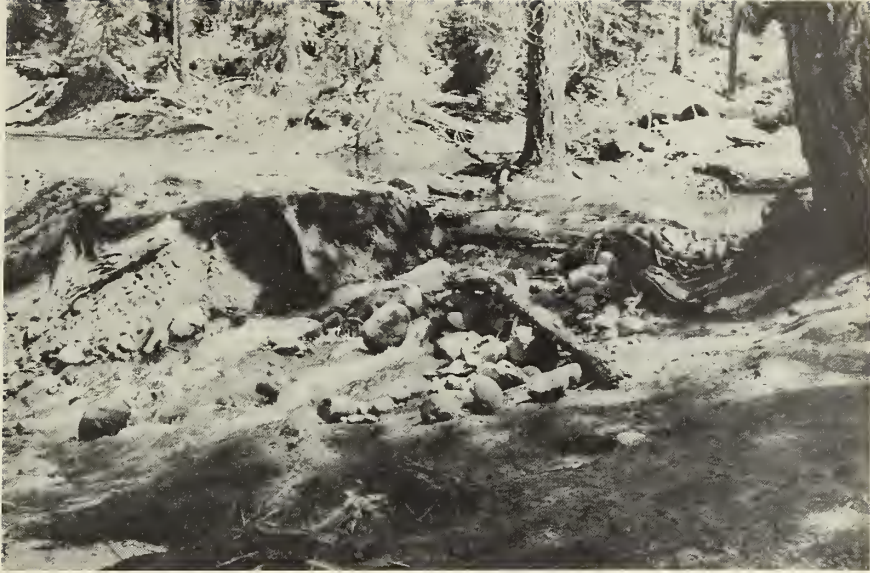
64.

Picture 64 shows what happens when temporary fills at stream crossings are not removed and the stream channels restored over winter. When this type of construction is permitted on temporary roads, the fills across streams or dry water-courses should always be removed at the end of the logging season or period of use. (See Maintenance).

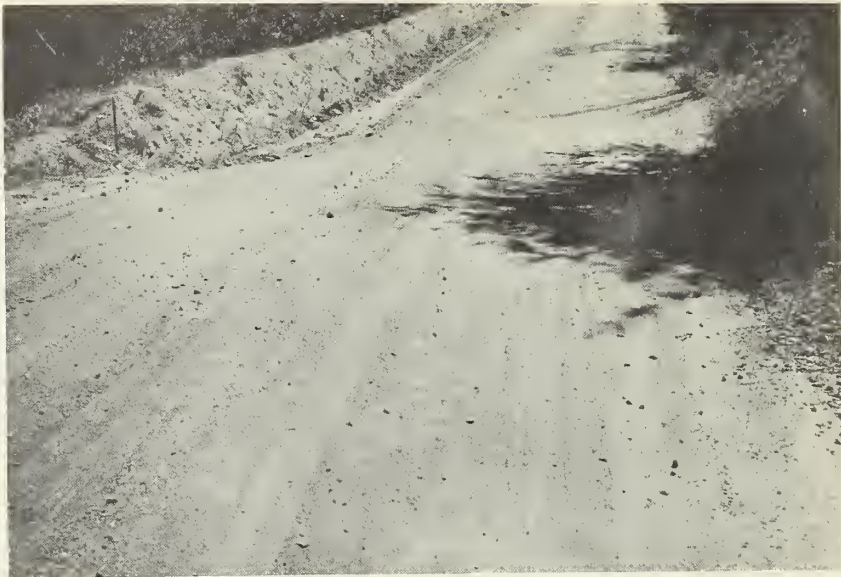
65.

An excellent example of dip construction, showing long roll and outslope to culvert (at stick left). Drainage dips of this type kept several miles of road open under very severe rainfall and ground conditions. The shape of dip should be modified to suit vehicle, speed, and load.

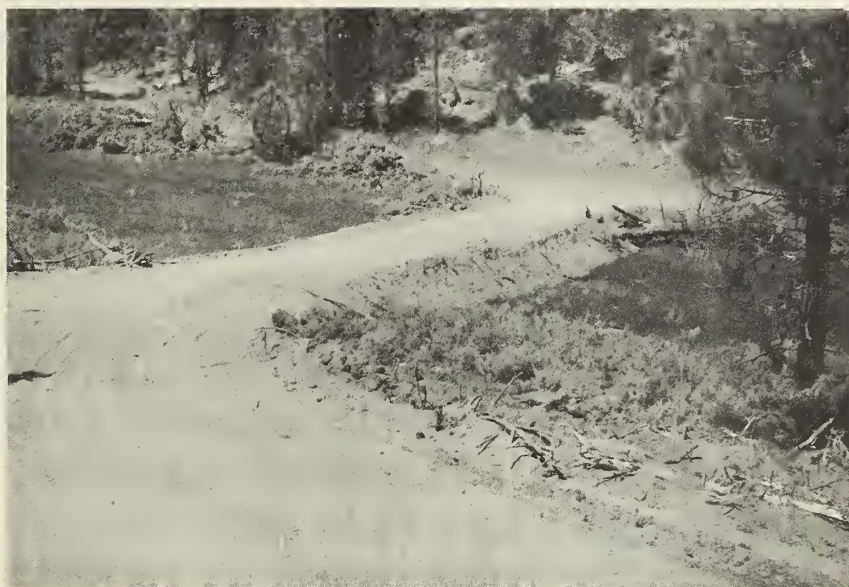
66.

Good example of road crossing a meadow with minimum disturbance. Crossing is located at a narrow point of the meadow and has a metal culvert (hidden by log at far side) large enough to carry run-off from local watershed. Note that fill is raised above meadow level, the fill material having been hauled in, and that no excavation has been made in the meadow.

When necessary to cross mountain meadows with logging roads considerable care is required in construction to avoid meadow damage. Crossings should be constructed as low through-fills with material borrowed from outside the meadows. Ample culverts should provide for drainage through the fills. Great care should be taken to avoid breaking the meadow sod. Picture 66 illustrates a good construction job in crossing a meadow, with the exception that clearing debris should not have been deposited on the meadow alongside the road.

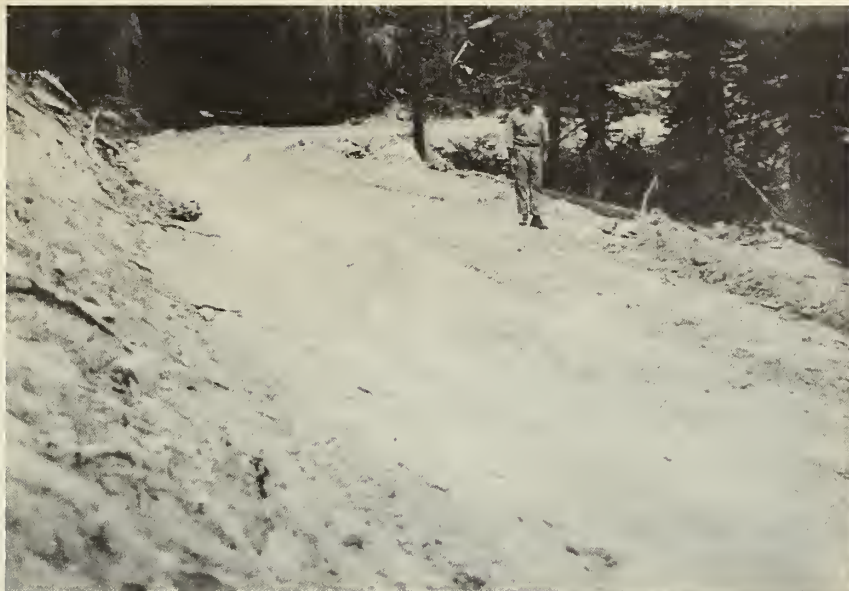
67.

Secondary road in decomposed granite, with good surface drainage for the winter season provided by numerous rolling dips about one foot deep, at 45° angle, and with a slight outslope.

Figure 8 and Picture 67 illustrate the proper method of installing waterbreaks for winter when some traffic is expected to use the road in the "off" season.

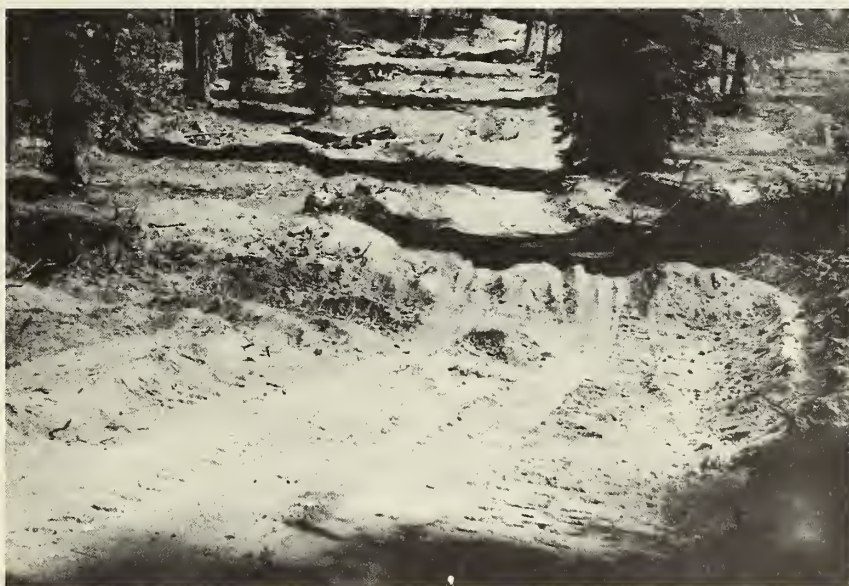
68.

Temporary road in very light decomposed granite soil showing improperly built waterbreak, with obstructed outlet and a berm that is too high and is placed squarely across the road instead of at an angle of 40 or 45 degrees.

Picture 68 shows a waterbreak built at right angles to the road. Such a waterbreak is not self-cleaning; it tends to fill up and become ineffective.

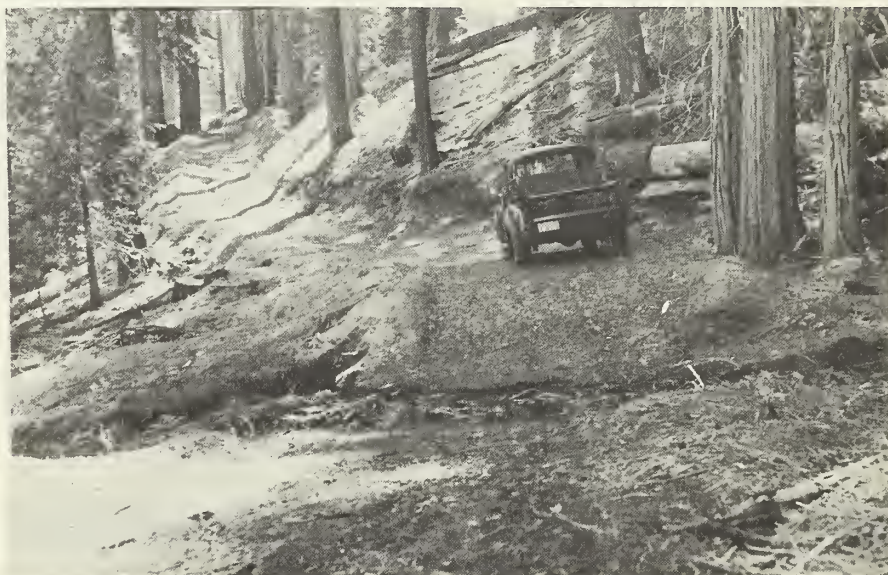
69.

Temporary road crossing of a small stream showing the channel properly cleared out after logging. Both fill and logging debris were removed. Erosion on road beyond car should be stopped by water breaks to drain off surface water.

Picture 69 illustrates the correct fill removal treatment at the end of the logging season or at final termination of use.

Picture 69 illustrates the proper method of removing temporary fills from a stream channel.

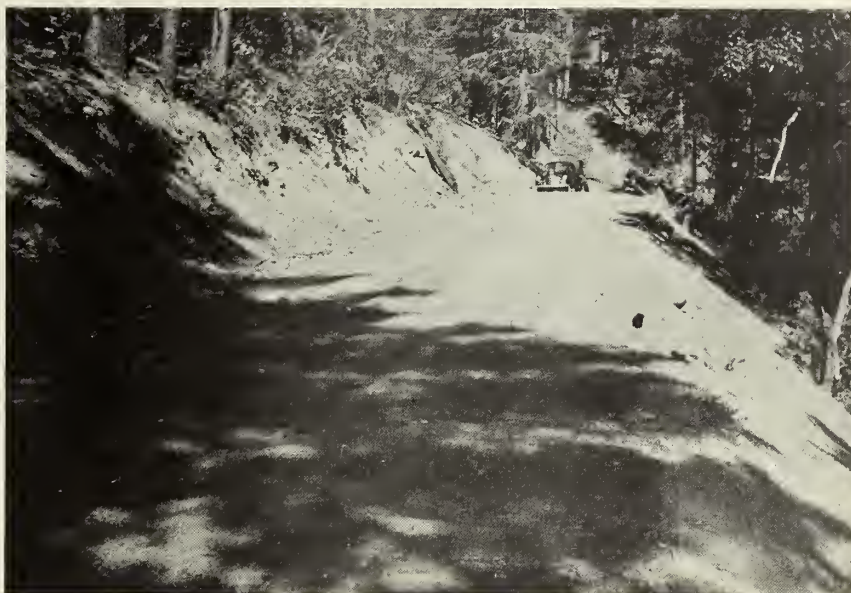
70.

Temporary road, on steep hillside (about 60%) in porous rocky shale soil, "put to bed" after completion of logging. Constructed on variable grade, with sloped cut-banks and slight outslope, this proved a very satisfactory road and required little treatment after use. The break in grade near car, and outslope, together prevent serious erosion in this soil type, thus maintaining the roadbed for possible future use.

Picture 70 shows a retired road treated in this manner.

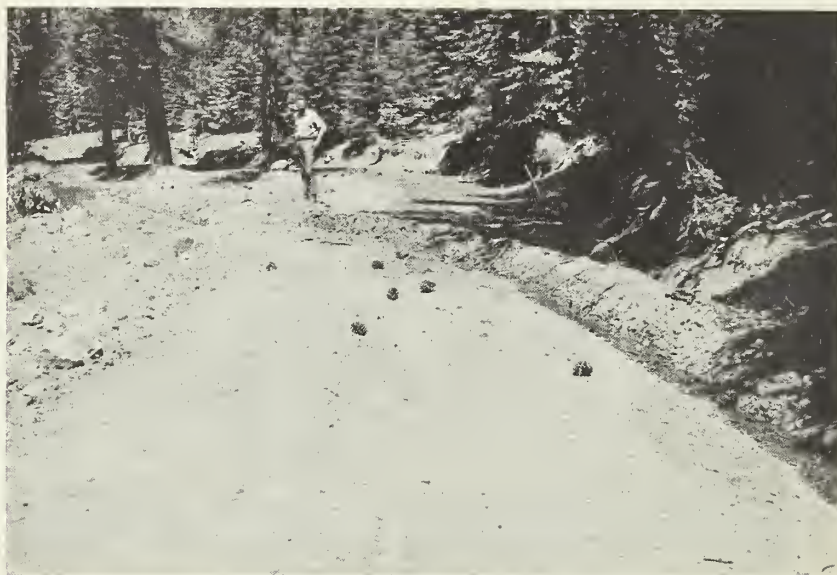
71.

Secondary road with well built water break, installed at a good angle and of sufficient size to provide effective protection for winter conditions. However, if road is to be traveled during the winter, the break is too abrupt. Both ditch and berm should be broadened into a dip-and-mound profile so that vehicles will roll rather than bounce over them.

Pictures 71 and 72 show examples of water break construction in temporary roads.

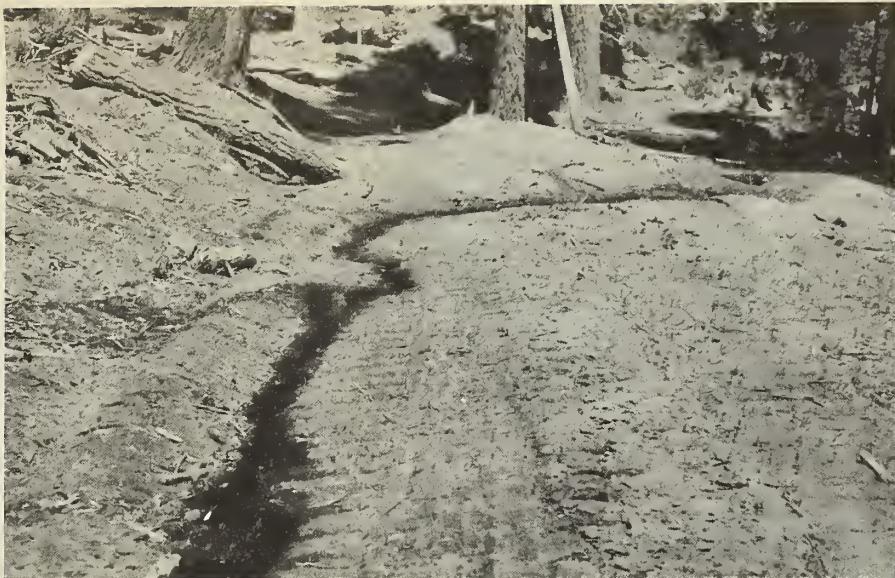
72.

Drainage ditch and water break in abandoned temporary road functioning effectively after one winter. It would be more dependable if both ditch and cross ditch were somewhat deeper. Another water break exists just beyond trees. There is no erosion, and vegetation is becoming established in the road.

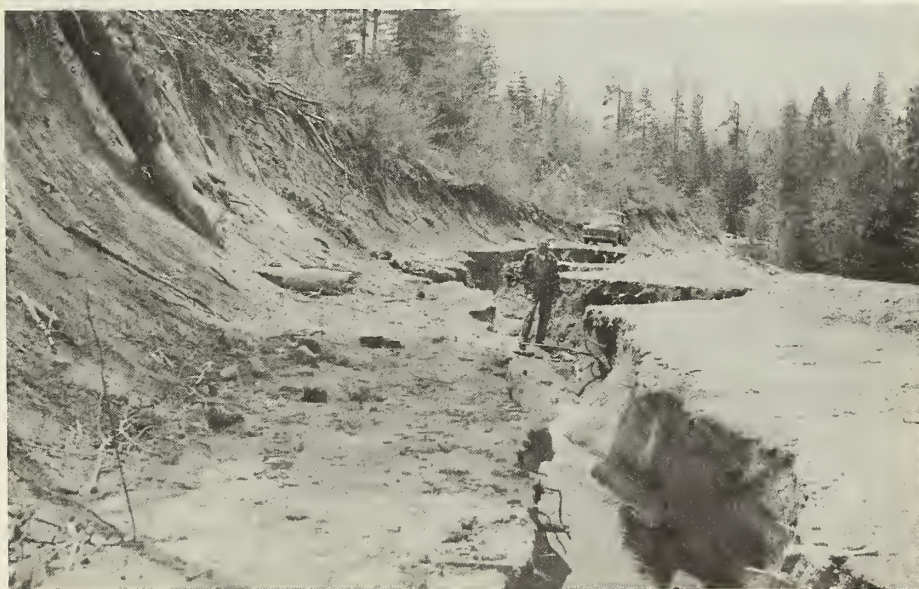
73.

Abandoned logging road in decomposed granite soil severely eroded as the result of inadequate drainage. Upon abandonment water-breaks, at least, should have been constructed. Preferably the roadbed should have been scarified and planted, since this is site 1A sugar pine land. The gully should now be checked, because the eroded material is being deposited in an irrigation reservoir downstream.

Pictures 73, 74 and 75 illustrate what happens when badly needed water breaks are not installed.

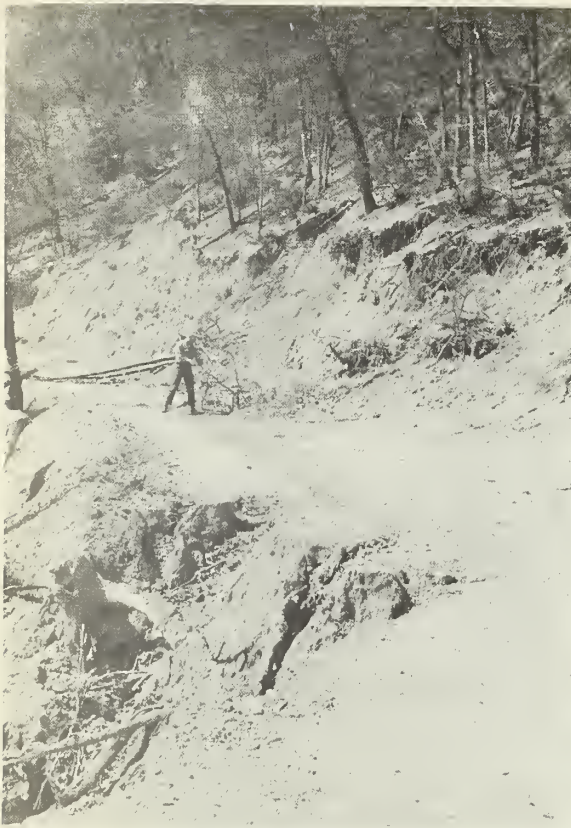
74

Abandoned temporary road in rocky soil showing severe erosion of outside shoulder and berm by accumulated water from one-eighth mile of road. Heavy bank slough forced water over against the outside berm, causing the washout. In this case, the treatment after logging should have included removal of the berm and installation of frequent water breaks.

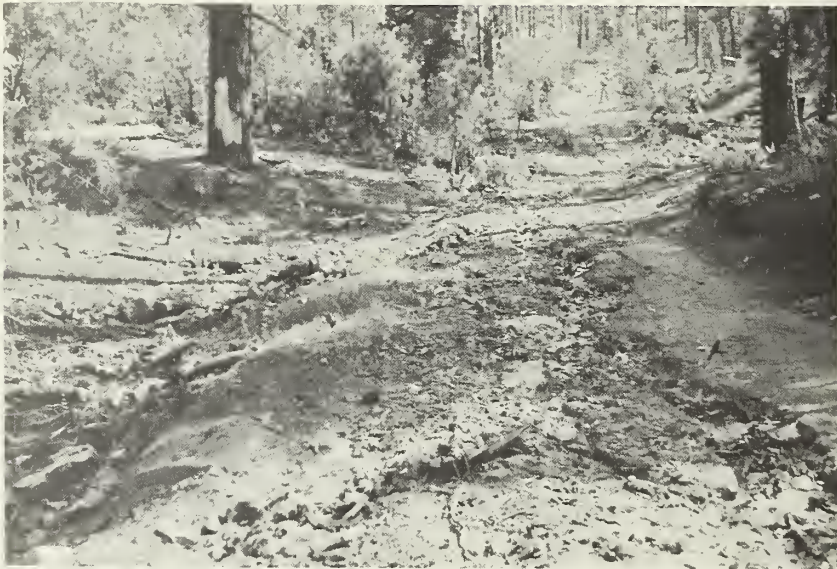
75.

Diversion of winter flow of an intermittent stream down this abandoned temporary road cut out much of the road and deposited the debris on a small meadow. The direct cause was the excavation of the stream bank in foreground and failure to replace it, and failure to clean out and deepen the stream channel after logging. Heavy water-breaks at close intervals would also have helped the situation.
